The Apollo 13 accident, which aborted man's third mission to explore the surface of the Moon, is a harsh reminder of the immense difficulty of this undertaking.

The Apollo 13 Review Board was charged with the responsibilities of reviewing the circumstances surrounding the accident, of establishing the probable causes of the accident, of assessing the effectiveness of flight recovery actions, of reporting these findings, and of developing recommendations for corrective or other actions. The Board has made every effort to carry out its assignment in a thorough, objective, and impartial manner. In doing so, the Board made effective use of the failure analyses and corrective action studies carried out by the Manned Spacecraft Center and was very impressed with the dedication and objectivity of this effort.

# TABLE OF CONTENTS

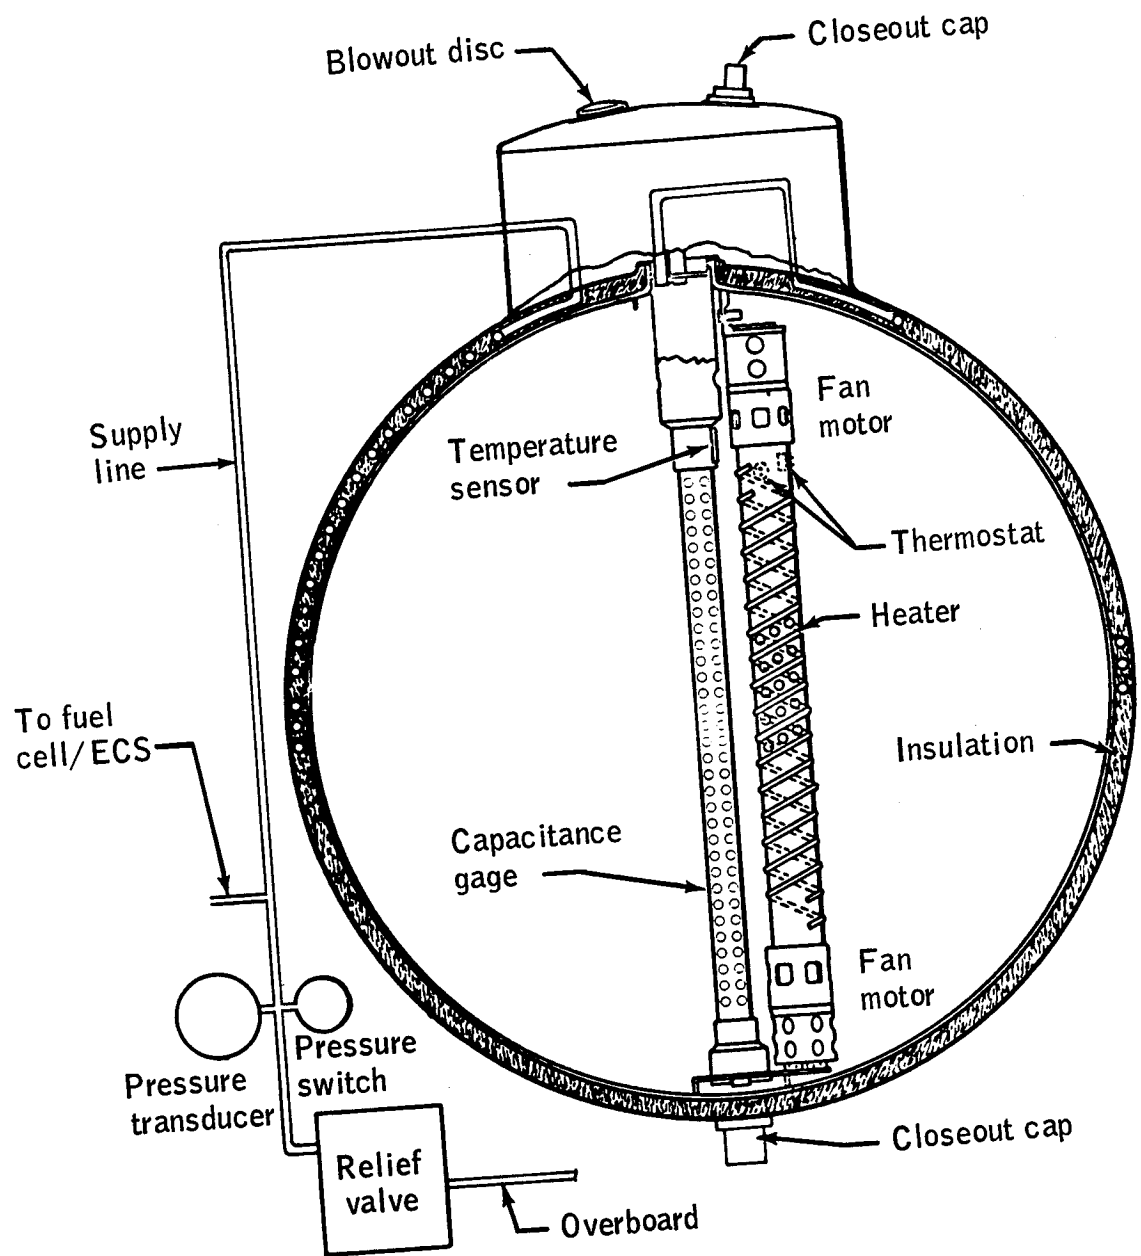
Figure 4-1.- Oxygen tank no. 2 internal components.

The supply line from the tank leads from the head of the quantity probe to the dome and thence, after passing around the tank between the inner and outer shells, exits through the dome to supply oxygen to the fuel cells in the service module (SM) and the environmental control system (ECS) in the command module (CM). The supply line also connects

to a relief valve. Under normal conditions, pressure in the tank is measured by a pressure gage in the supply line and a pressure switch near this gage is provided to turn on the heaters in the oxygen tank if the pressure drops below a preselected value. This periodic addition of heat to the tank maintains the pressure at a sufficient level to satisfy the demand for oxygen as tank quantity decreases during a flight mission.

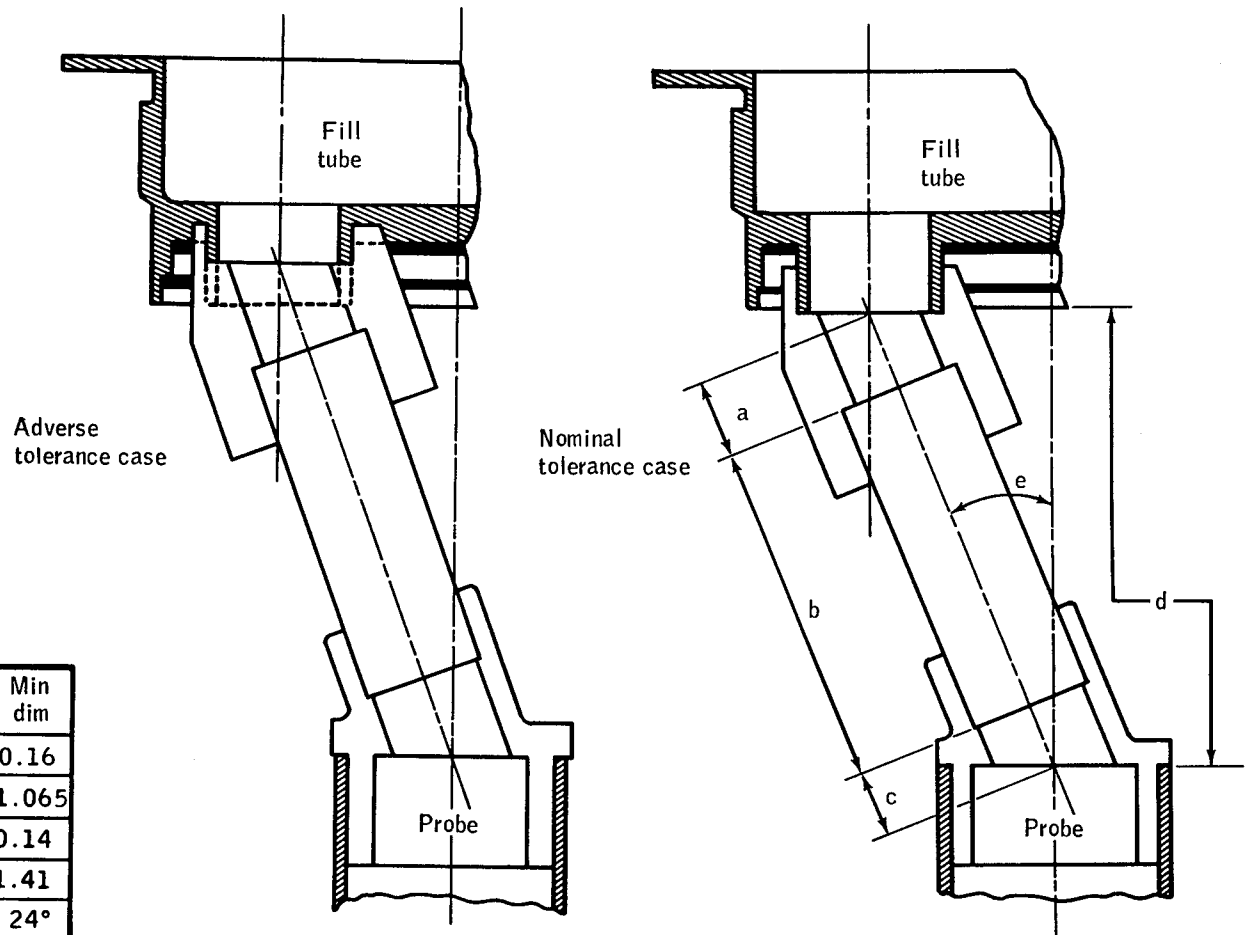
Figure 4-3.- Nominal and adverse tolerance cases.

Part	Max dim	Nom dim	Min dim
a *	0.28	0.24	0.16
b	1.095	1.080	1.065
c	0.26	0.20	0.14
d	1.45	1.43	1.41
e	18°	21°	24°

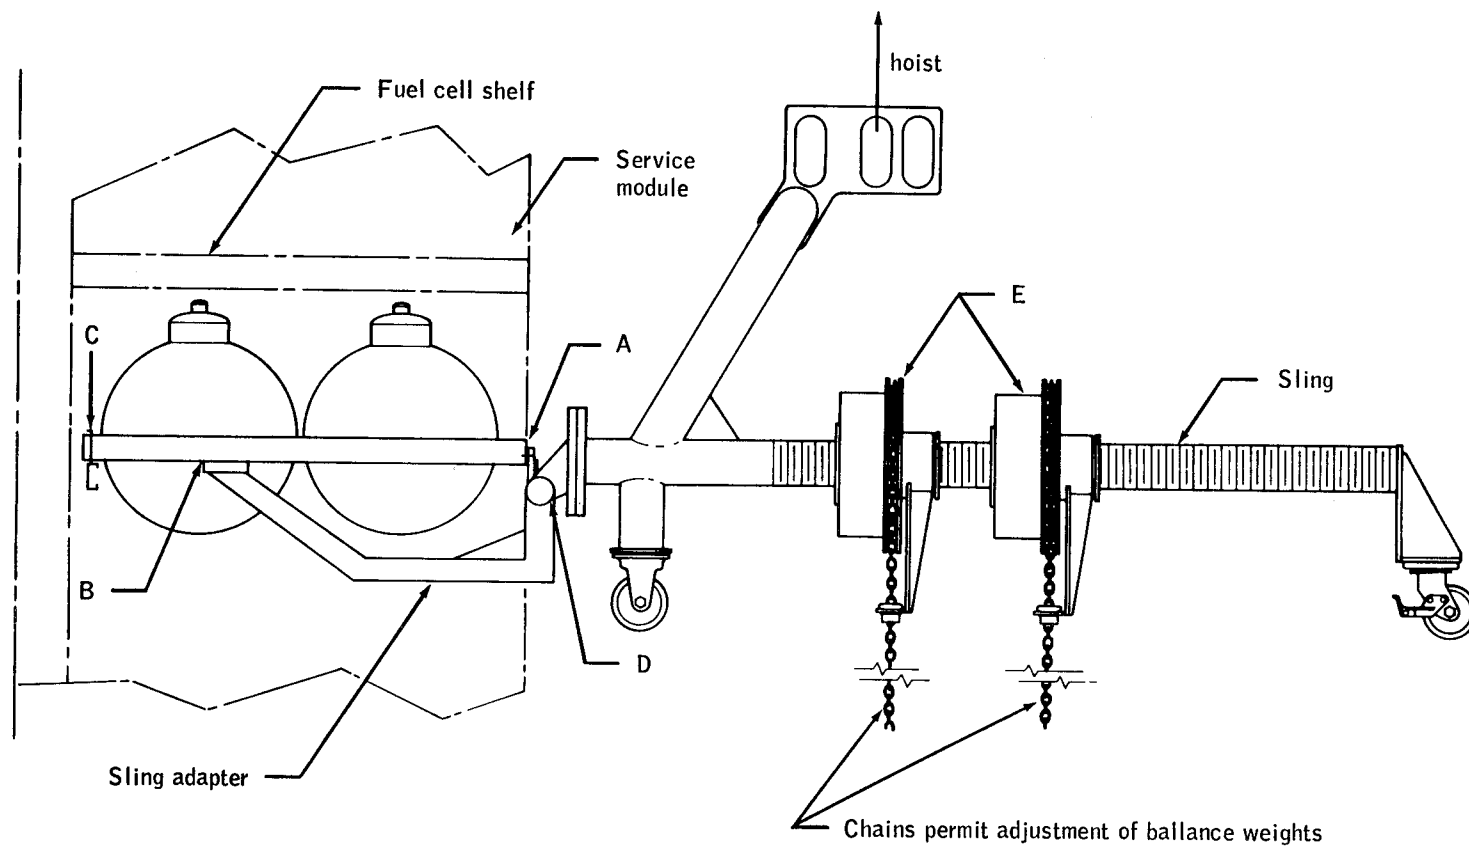
Figure 4-9.- Hoist and sling arrangement - oxygen shelf.

calculated assuming a 2-inch drop only. The probability of tank damage from this incident, therefore, is now considered to be rather low, although it is possible that a loosely fitting fill tube could have been displaced by the event.

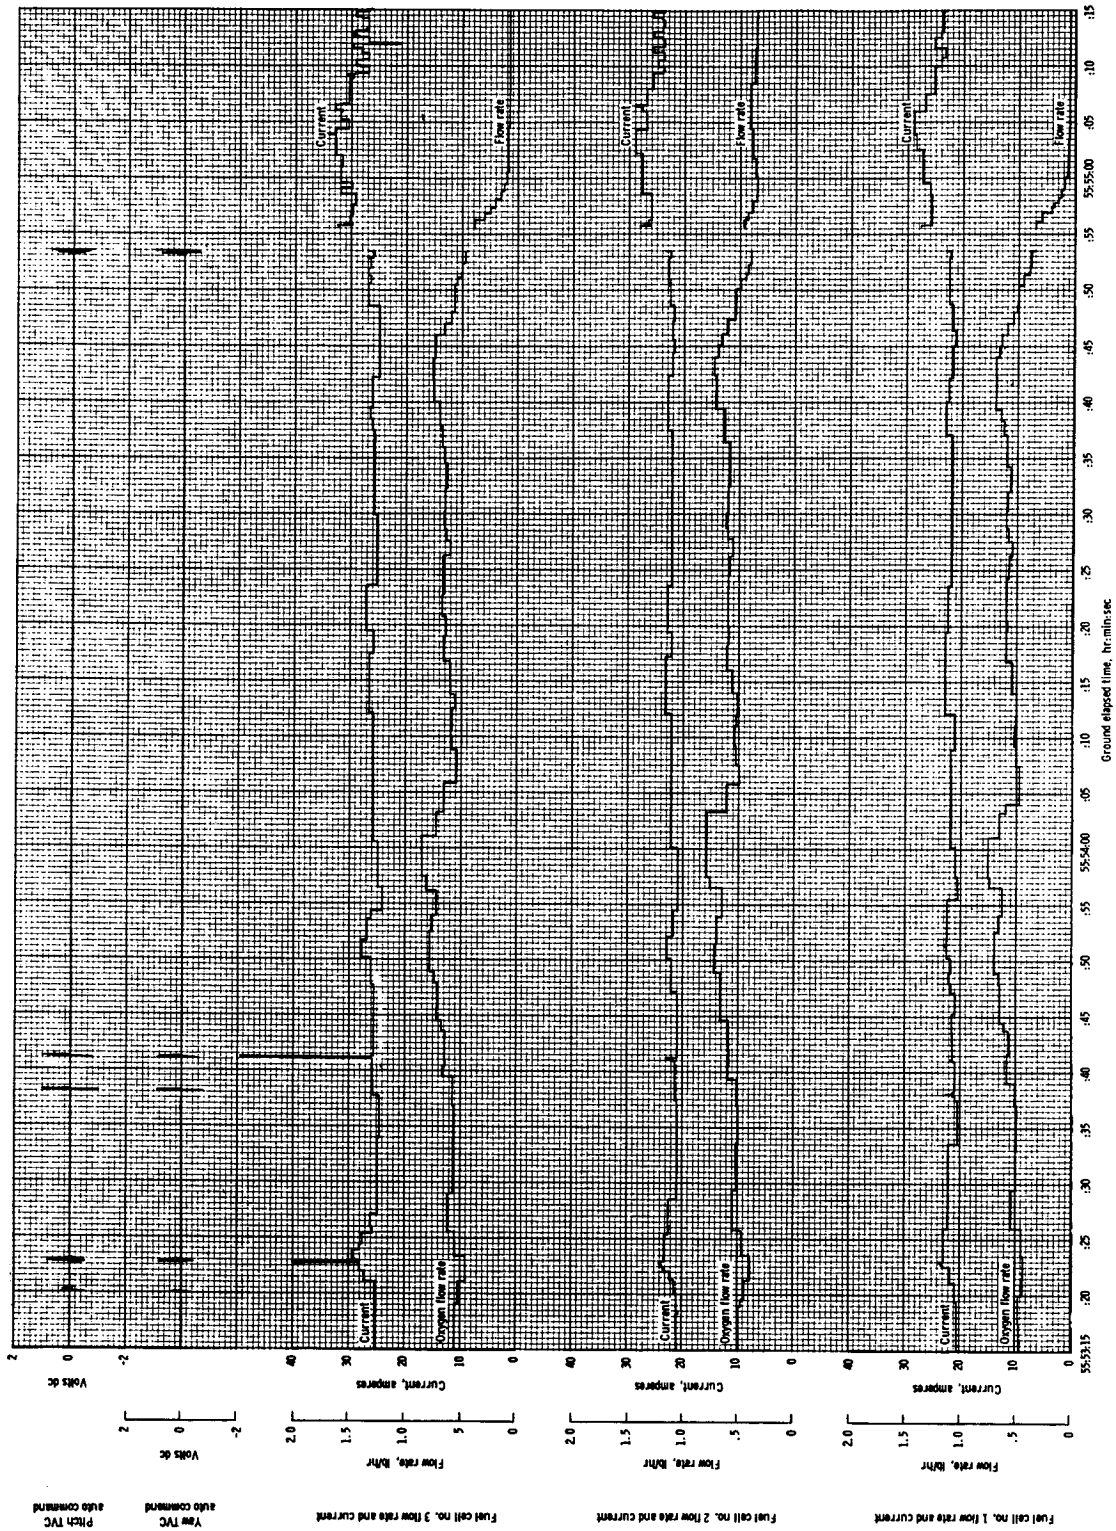
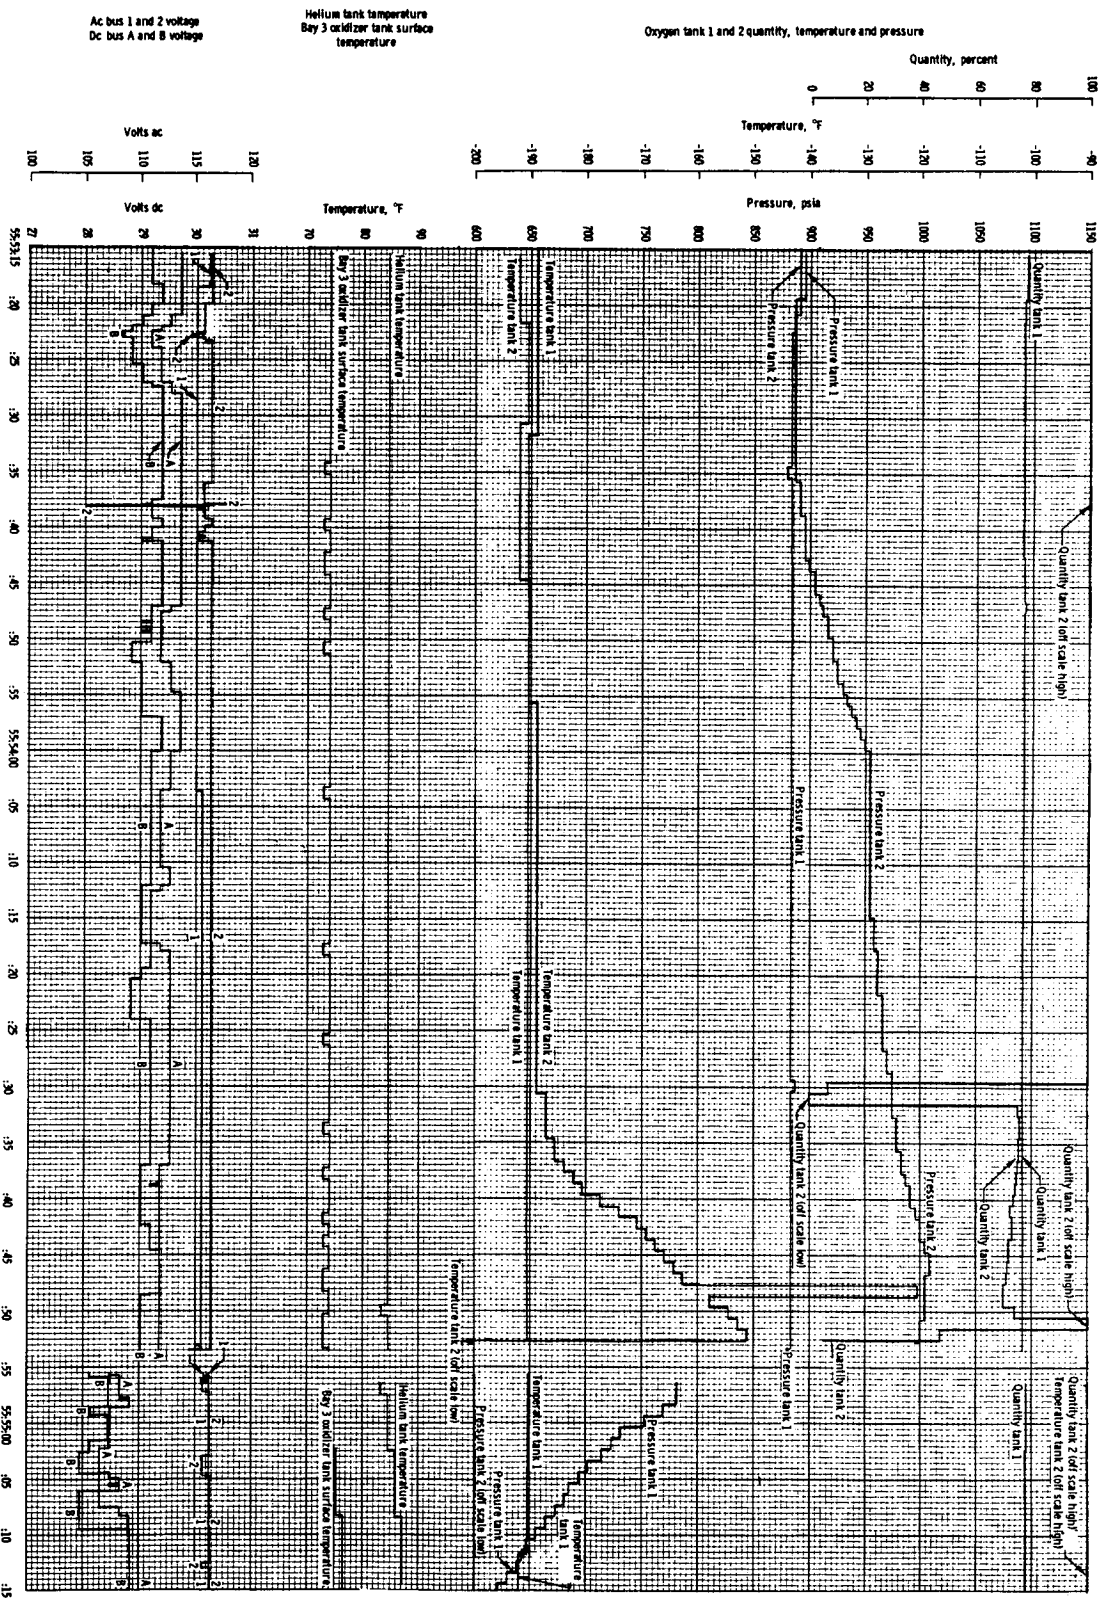
Figure 4-10.- Telemetry record.

The various telemetered parameters of primary interest are shown in figure 4-10 and listed in table 4-11.
